**Metropolitan Bible Church Façade**  
**453 Bank Street**  
**Ottawa, Ontario**

**Metropolitan Bible Church [JCAL 2008]**

**JCAL Project No. 08024**  
**July 2009**

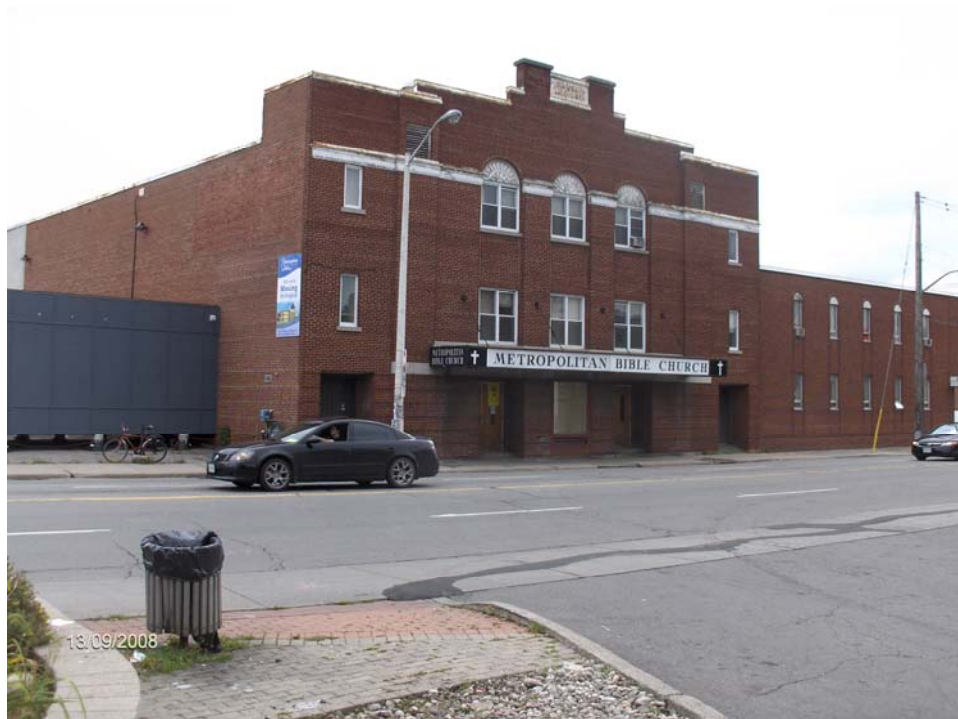
Picture 1 Exterior Façade: View from the north west corner of the building

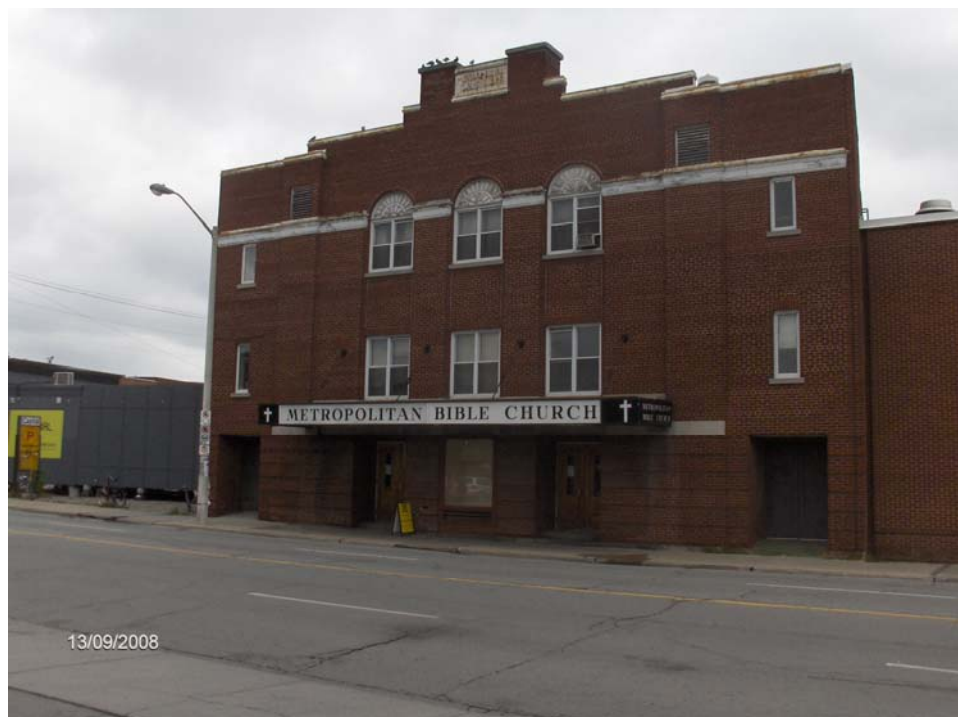
Picture 2 Exterior Façade: View from the south west corner of the building

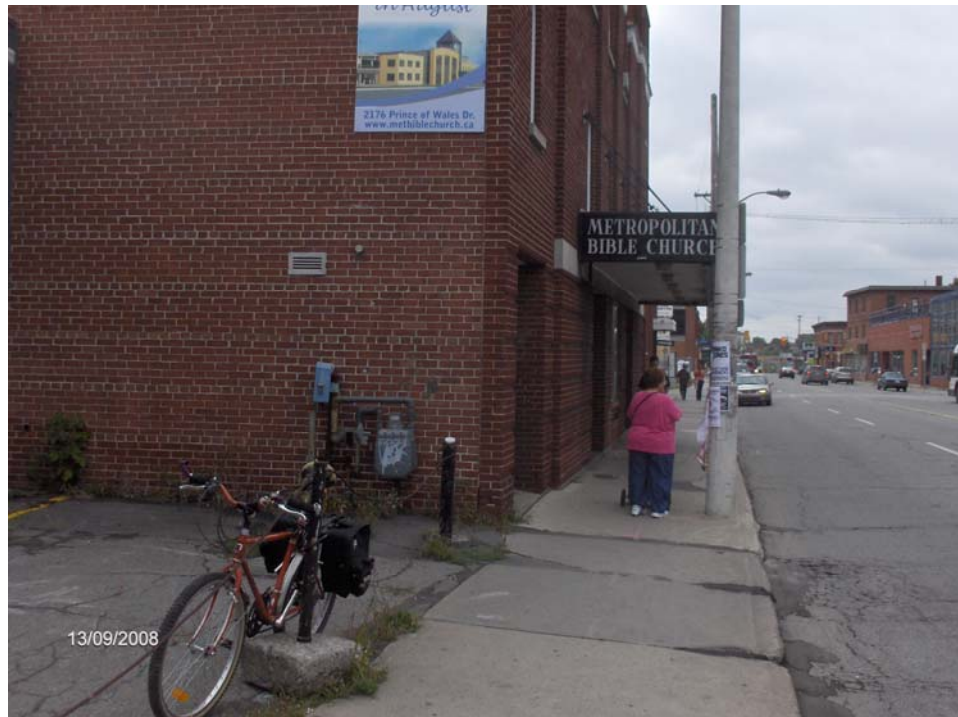
Picture 3 Exterior Façade: Bottom of the north elevation

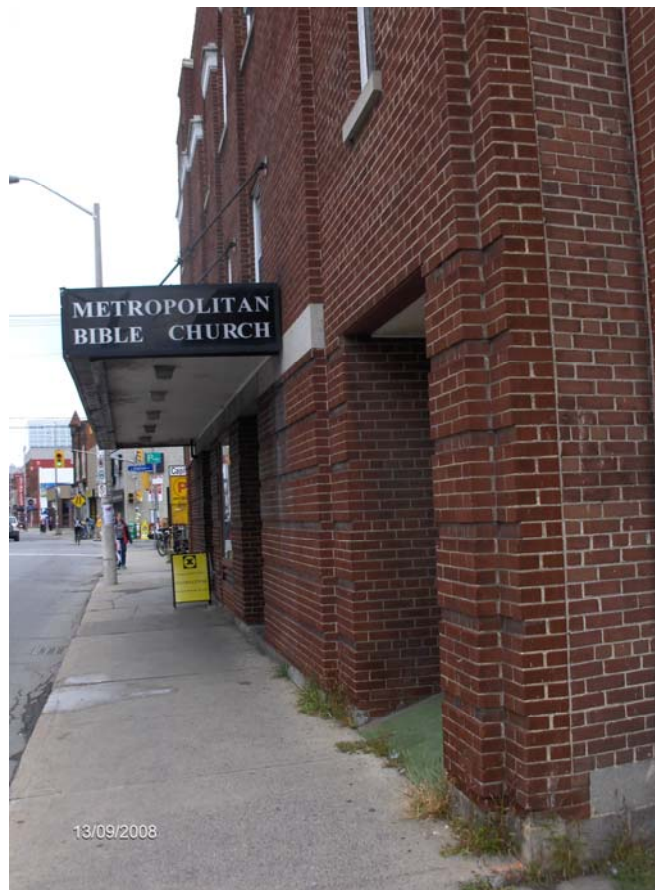
Picture 4 Exterior Façade: Bottom of the south elevation

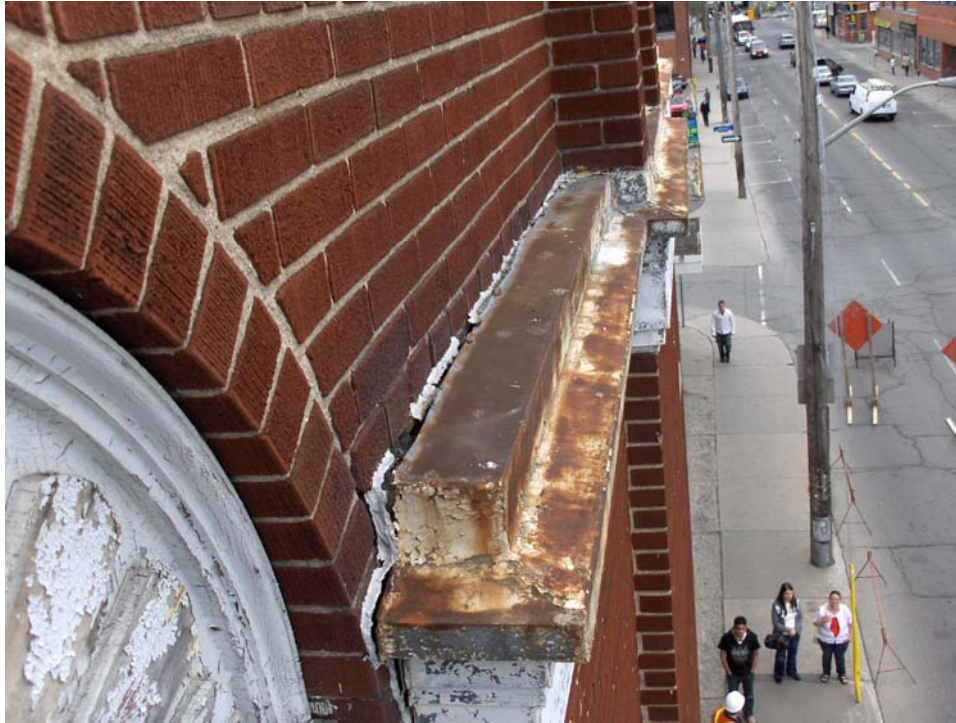
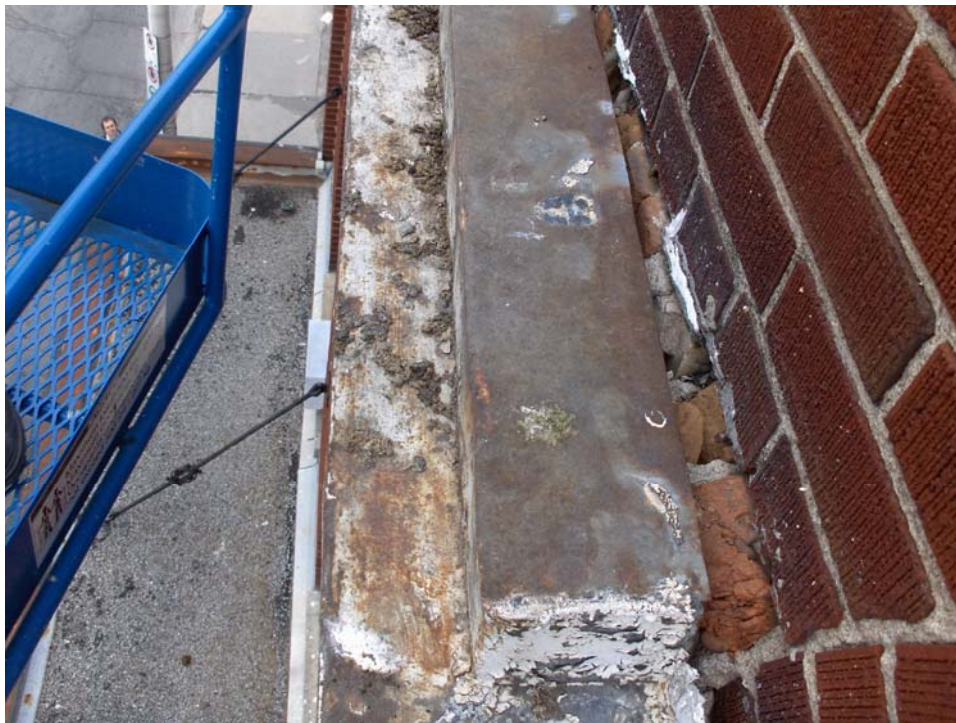
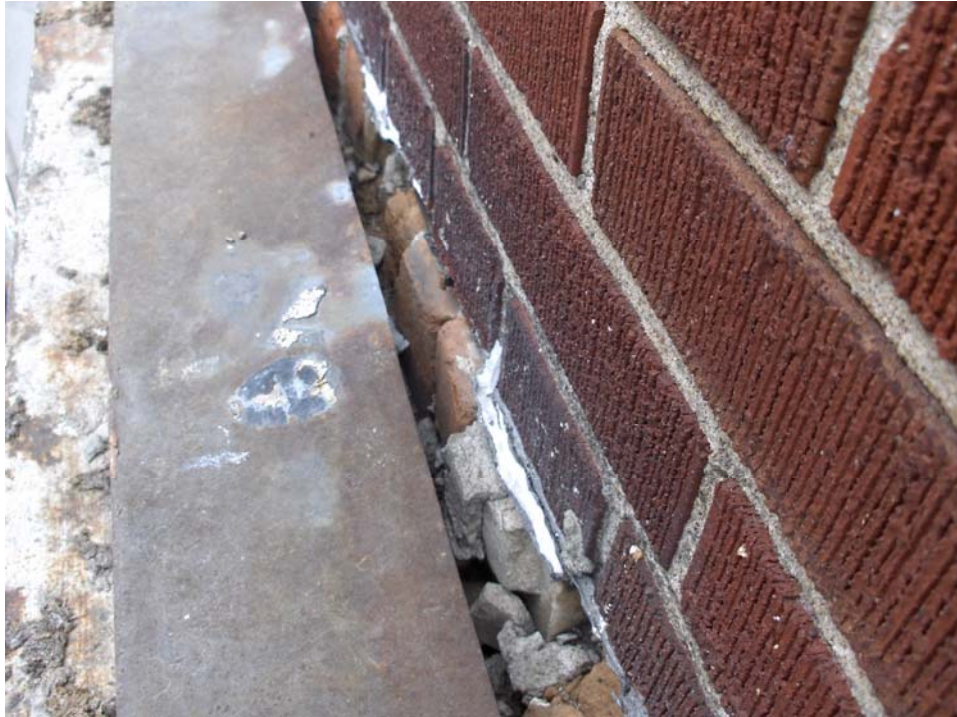
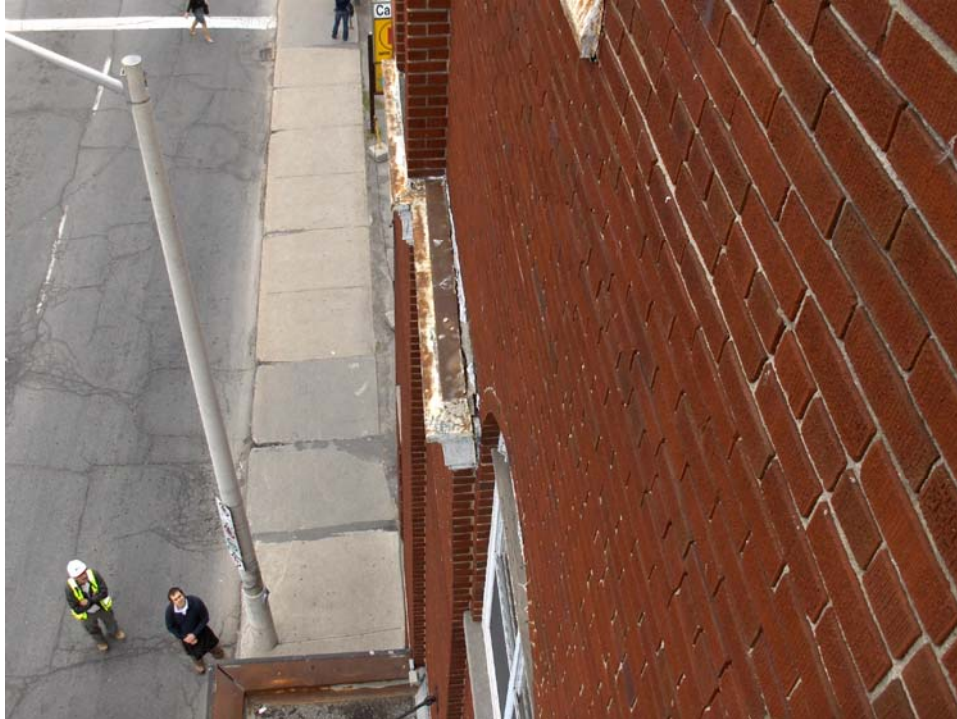
At the metal feature strip, it was noted that the detail was poor. The metal did not finish into a reglet. Instead, it finished flush with the wall and was caulked. The detail subsequently failed, allowing the metal to pull away from the wall. Moisture could infiltrate the brick behind the flashing. As can be seen from the photographs (see sections 2.1.2), the brick is of inferior quality to the exterior brick, and is badly deteriorated, thus weakening the wall at this location.

- .1 At the metal cornice, the metal is rusting and is in poor condition. The detail is very badly done, with the upper horizontal surface of the cornice terminating at the face of the brick, with no reglet of any kind. The weather seal is totally dependent on the sealant which has failed. The water infiltrates behind the metal cornice, so the poorer quality brick used behind the cornice is deteriorating, and mortar in the brick joints is eroded. The metal cornice is pulling away from the wall but is not in danger of falling at this time.

Picture 5 Metal feature strip at third floor windows

Picture 6 Metal feature strip at third floor windows

Picture 7 Metal Feature Strip at third floor windows

Picture 8 Metal feature strip at third floor windows

During the reconstruction, a similar compatible historic brick will be used to replace the damaged brick behind the metal ledge. Brick will also be salvaged from the backside of the chimney to replace brick damaged during dismantling of the upper wall.

- .1 The metal cornice will have to be replaced. Ideally, it should be replaced with copper for longevity and minimum maintenance. The metal must be properly detailed to finish into a reglet in the brick above the ledge.

During the shoring, this cornice, which is loose, will have to be removed. The profile of the cornice must be accurately recorded. The brick band behind will have to be repaired by replacing deteriorated brick, and repointing joints, before the building is demolished, as this band is creating a weakness in the wall at this point.

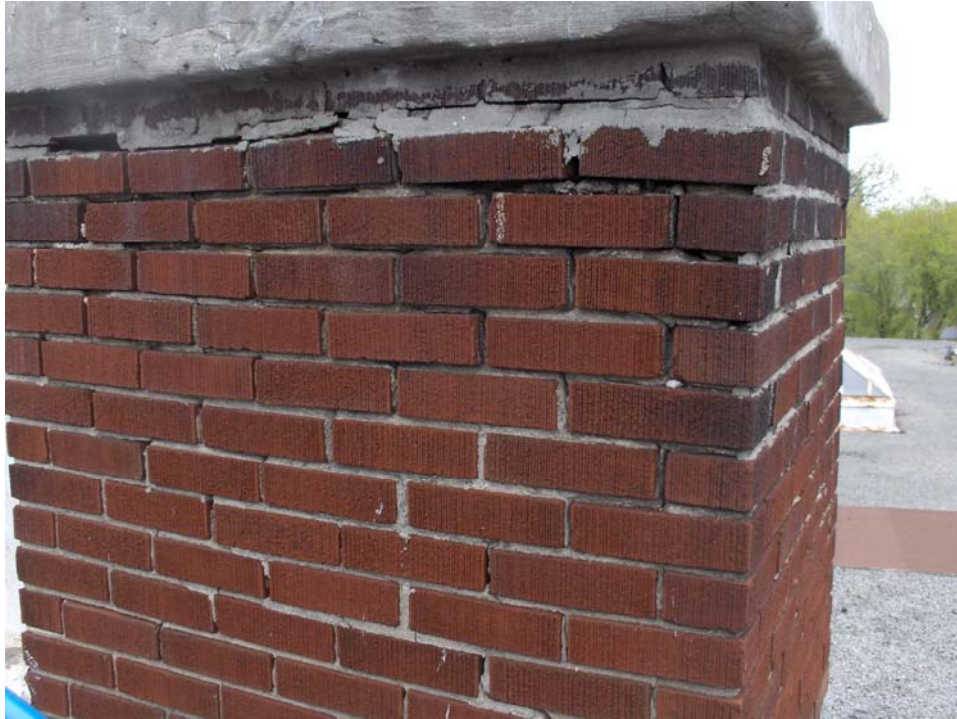
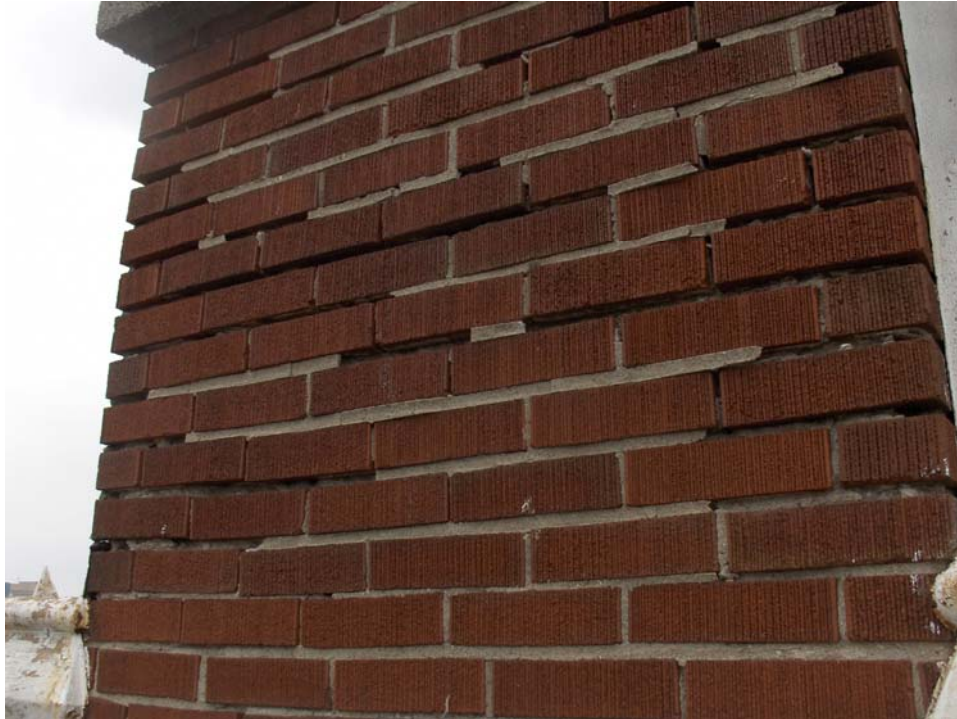
At the chimneys, and along the roof line, the mortar joints have deteriorated, and some of the brick is loose.

- .3 At the large south chimney, the brick joints are in poor condition for the extent above the roof, with mortar cracked, debonded or eroded. Some of the brick is bulging. Many bricks appear to be loose. This chimney is still in use so it is not capped. The brick liner inside the chimney is in very poor shape. Most of the brick mortar joints are void, and some brick is deteriorated. Some attempt to repoint brick joints was made on the north east, and south sides of the chimney on the exterior face.

- .4 The north chimney is capped, but the brick condition is similar to the south chimney, with poor condition of mortar joints, and deteriorated brick. On the east face, there is a noticeable bulge in the brick face.

Picture 9 Chimney

Picture 10 Chimney

- .2 Given the condition of the brick parapet and the chimneys in the centre, the brick construction above the parapet will largely have to be reconstructed. In light of this condition, I would recommend careful demolition of the brick above roof level, and possibly even several courses below roof level (this will depend on the condition of the upper brick courses after the cap flashing is removed), prior to building demolition.

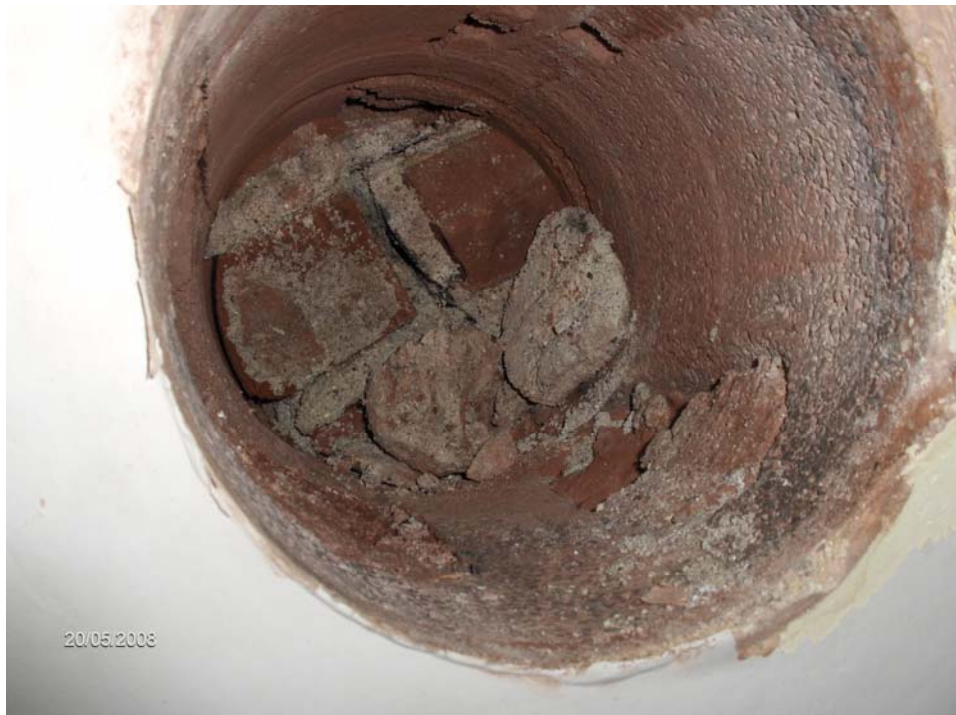
The same wall construction was noted at all three core locations. The wall is 16½" thick. It is made of either two 8" concrete blocks or a 12" and a 4" concrete block with a ½" thick parging/plaster on the inside face. The concrete block units and the mortar were found to be in good condition.

Picture 11 Core sample at the second floor

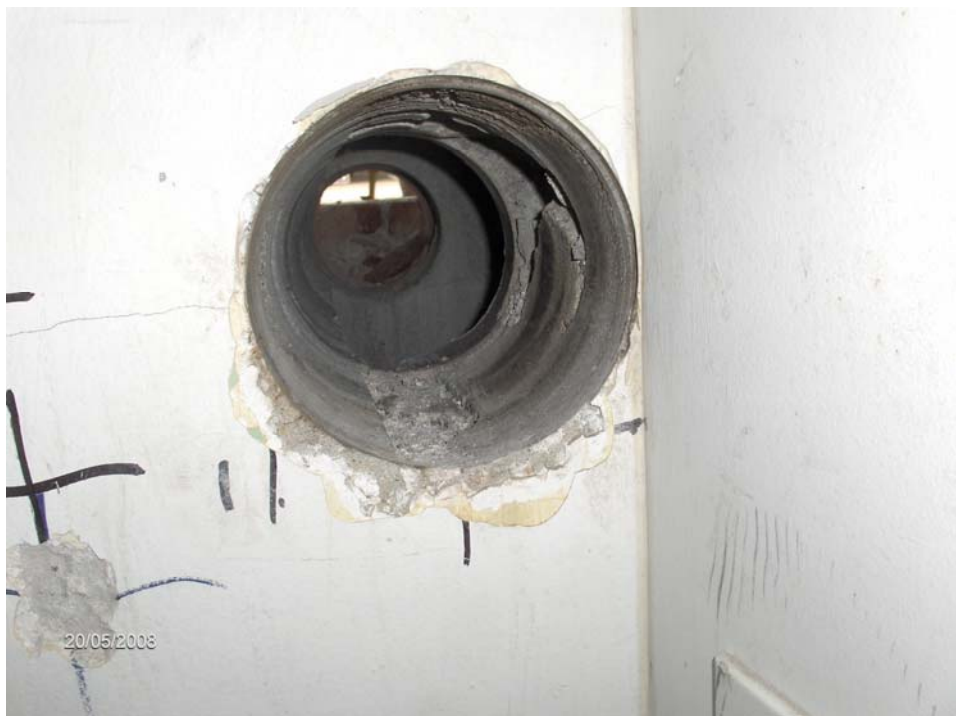
Picture 12 Core sample at the ground floor

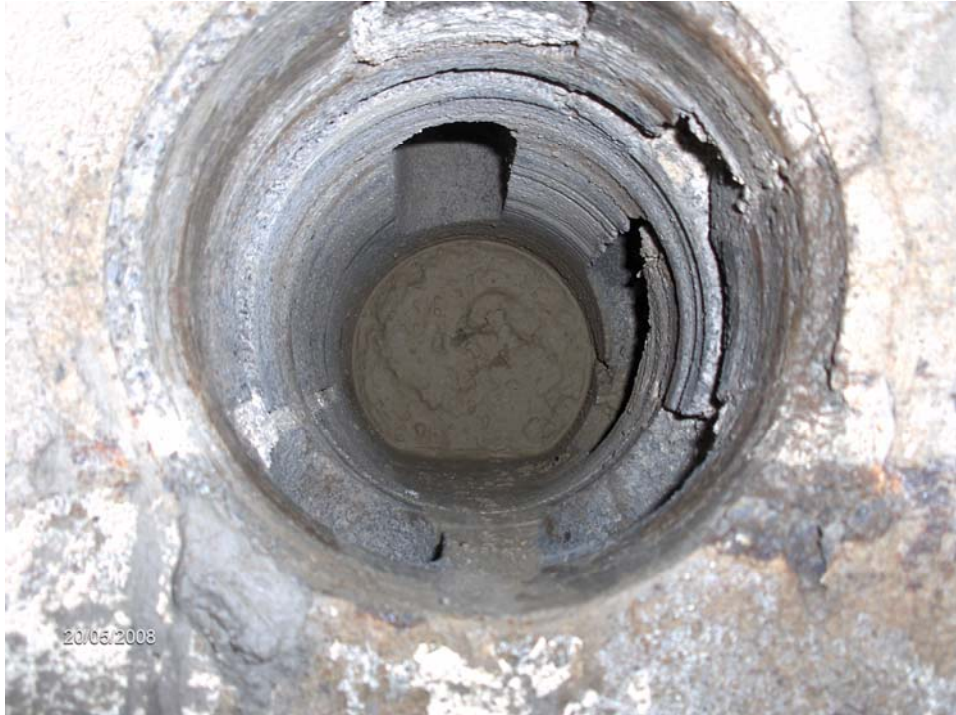
The wall construction is as follows: 3½" brick, ½" space, 8" concrete block, and ½" thick parging/plaster on the inside face. The concrete block units were found to be in good condition. The mortar was found to be weak and easy to debond.

Picture 13 Core sample in basement

As additional recommendations from the letter of May 8, 2008, which addressed the exterior brick, an allowance should be provided to repoint a portion of the block. The condition of the concrete block units and mortar need to be re-assessed once the wall finishes are removed. For pricing purposes, an allowance for repointing of 10% of the block joints should be included in the bid documents. Also, an allowance will need to be carried to infill any mechanical openings or pockets found in the wall.

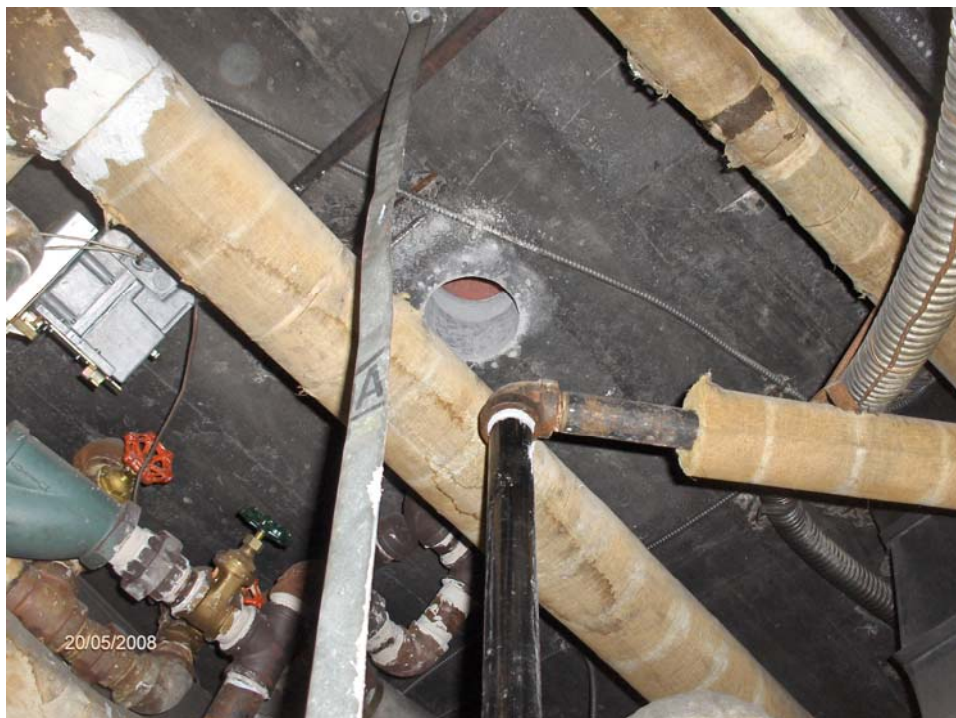
Picture 14 Core sample through ground floor slab
