BURKHOLDER BUILDING
BANK STREET, OTTAWA

HERITAGE STRUCTURE REPORT

The Burkholder Building was visited a number of times in early November 2005, in order to understand its original design, ongoing evolution and present condition. This is a report on those findings. The investigation was preliminary, and there will be a requirement for more detailed investigations and design development if part of the building is to be retained.

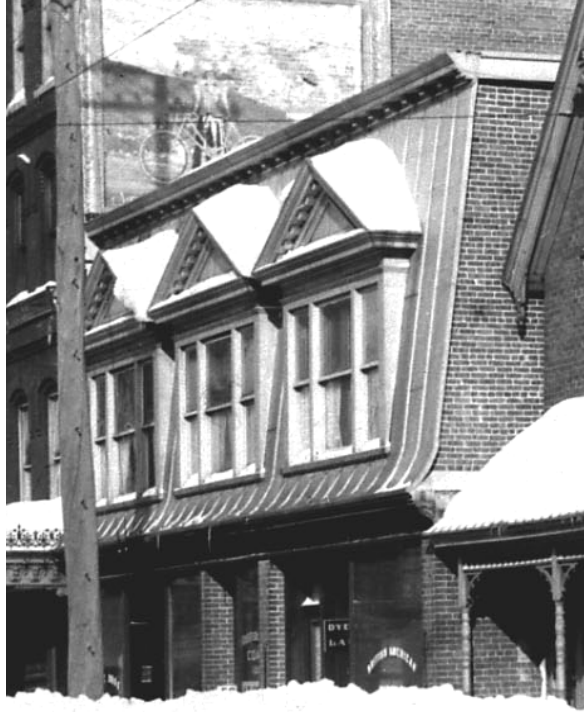
Fig. 1. Historic photo showing lower floor divisions into two larger bays and one small central bay.

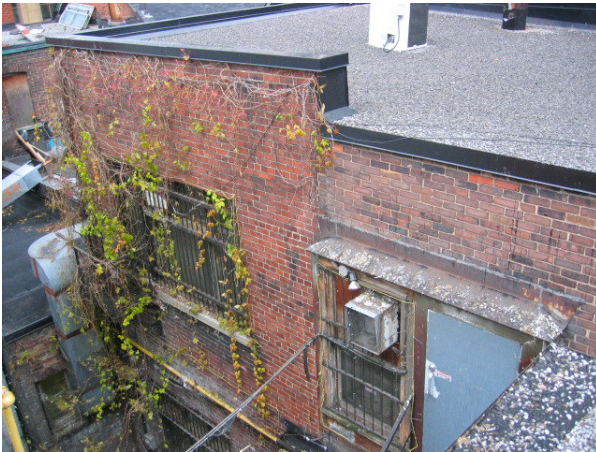
The rear façade indicates the separate building volumes. The brickwork changes in colour and pattern at the junctions, and the rear bays are different sizes.

Fig. 2 Rear elevation showing building divisions – south and central bays

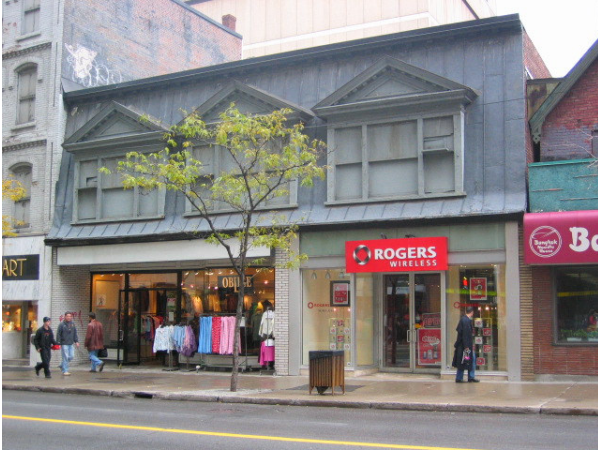
Fig. 3 Current appearance. A single modern storefront on the left replaces the earlier two bays. Also visible in this photograph is the lack of alignment of the southern bay (on the right) with the pattern established by the dormer windows above.

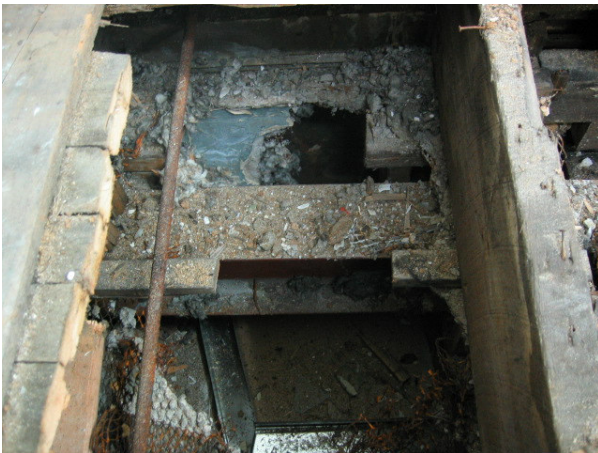
Fig.4. The original hardwood floor is visible on the left, above the 2x10 wood joists @ 24"o.c. Immediately below is one of the series of east-west 8" deep steel beams, and below these is a welded bracket and a 14" deep north-south steel beam.

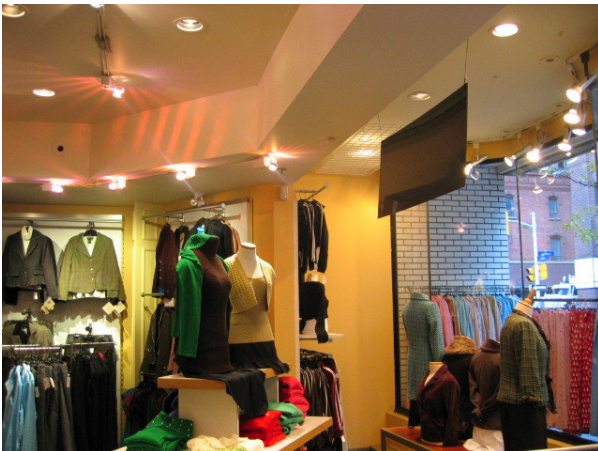
Fig.5 The current retail space on the ground floor of the northern bays. The boxed-in beam contains one of the 14" north-south steel beams. The front façade does not have one of these transverse beams, but is carried by the cantilevered 8" steel beams above.

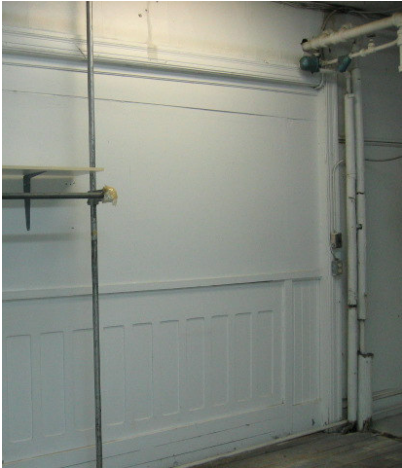
Fig.6 Upper floor, northern portion, showing typical early-twentieth century trim details.

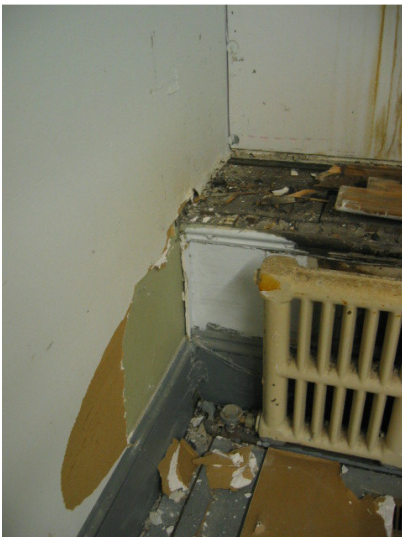
Fig.7 details showing intersection between bearing wall (left) and middle dormer (right). Original lath and plaster finish is visible behind later drywall. Baseboard and window sill are original.

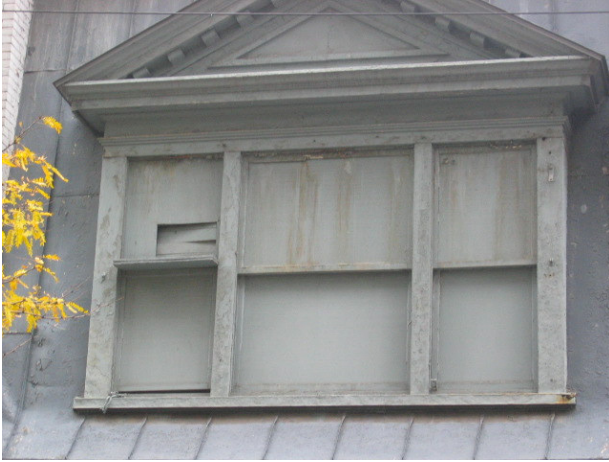
The dormer windows are relatively intact. On the exterior, the standing seam metal roof appears to be the original, repainted many times. The window trim retains its dentilled cornices. Much of the window sash survives, but some have disappeared, replaced with informal wood structures to hold air-conditioning units. On the interior, they have some remnants of their original lath and plaster finishes and wood corner beads, but there have been many other applied finishes. The structure of the mansard roof is composed of 3"x6" wood framing with 1"x6" sheathing boards.

Fig.8 Mansard roof with original standing-seam metal roofing, dormer with dentilled cornice, and original window sash in two of the three frame units.

If this element were to be retained, it would have to be removed while the rest of the building was taken down around it. It would then be reinstated in exactly its current location and configuration. This reinstatement would involve significant restoration or reconstruction of the roof elements. The standing seam metal roof is noticeably rusted along its lower edge, and may have to be completely redone. The window sash may need significant repair, and the missing sash would have to be replaced. As part of the reinstatement, it might be decided to use the original as a template and do an accurate reproduction.

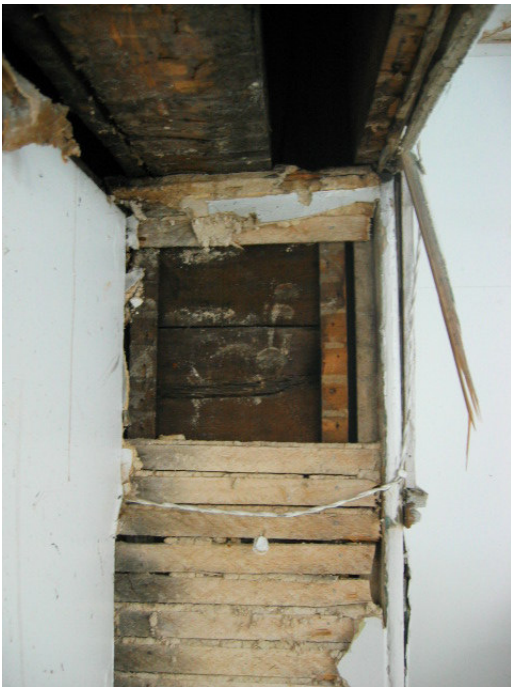
Fig.9 Interior view of the mansard roof, showing remnants of lath and plaster, with wood corner bead, and 3"x6" framing member above.

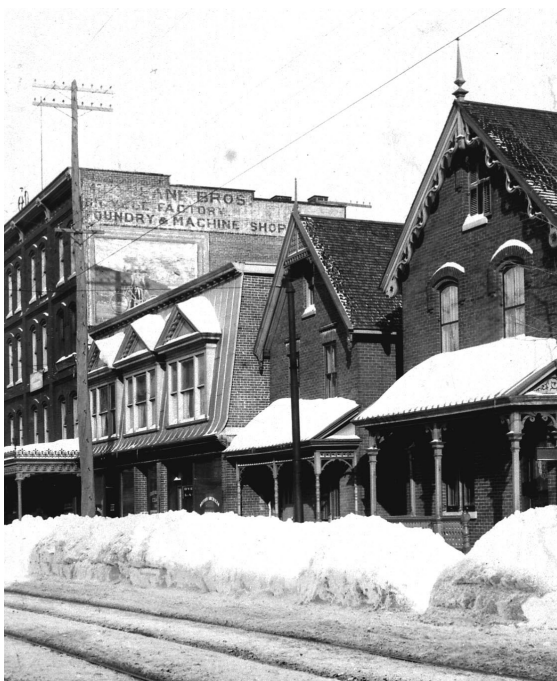
Fig.10 Historic reality

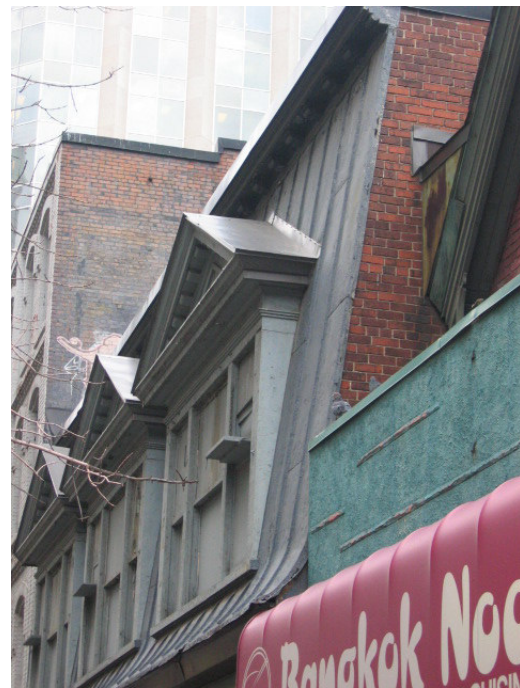
Fig.11 Contemporary reality
