SUBJECT/OBJET: **CRIME PREVENTION THROUGH ENVIRONMENTAL DESIGN**

REFERENCE: Lincoln Fields Transit Station

Audit Performed: November 10, 1999

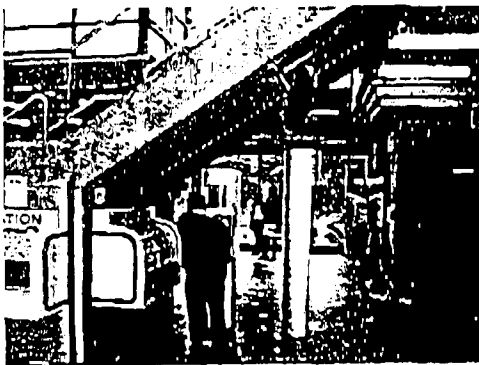
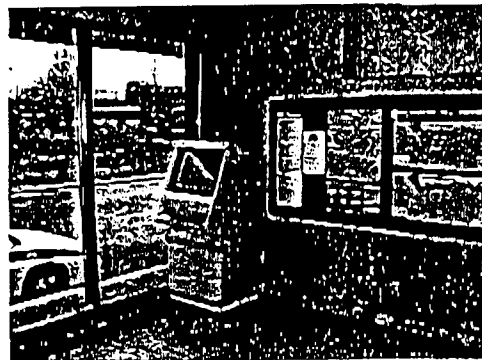
The telephones are located under the stairwell and away from the visual surveillance of most passengers and bus drivers. The telephon has also been located in a corner positioned in a manner that forces the user's back toward the main area. I would suggest that the phones and telephon be relocated to a central area to increase visual surveillance and eliminate any perception of fear by the users. I was advised that there is also a direct line to OC Transpo security via the payphones. This is a great idea; however, there were no signs indicating this.

<u>Item</u>	<u>Status</u>	<u>Completion Date</u>
Signage	• Regional Police to provide CPTED recommendations re signage	January 2000
	• Review and update of all station signage by Public Info	March/April 2000
Surveillance	• Pay phones and Teledon to be relocated to more visible area. (Public Info/Plant)	February 2000

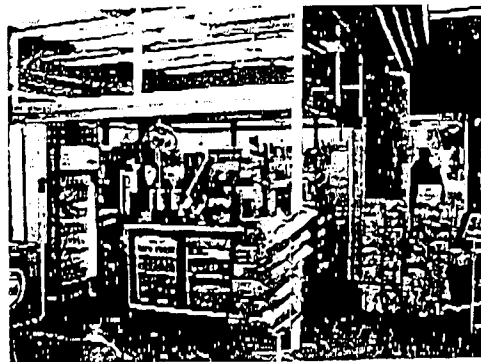
The exterior windows of the canteen were cluttered with shelving and cooling equipment. This eliminates the visual surveillance that the employee has toward the outside and that the passengers, bus drivers and law enforcement have of the store employee. If the employee was to be robbed, unless it was observed from inside the main stop, the anonymity of the suspect would be preserved. I would suggest that the store area be increased to accommodate additional shelf space and allow some of the window space to be cleared. Glass alarm contacts and/or protective glass covering can be installed to deter any break ins.

If there was additional space, the merchandise on the outer shelves could be turned inwards to prevent theft. Even with convex mirrors, it would make it very difficult for the store employee to observe theft, especially if there is more than one customer waiting for service.

• Canteen area will be reviewed re window clutter by security	February 2000
Overpass Leading to Carling Avenue	• Entrance lighting upgrade (Plant)	March 2000
